CLINICAL CASE: SINUS LIFT AND BONE GRAFT

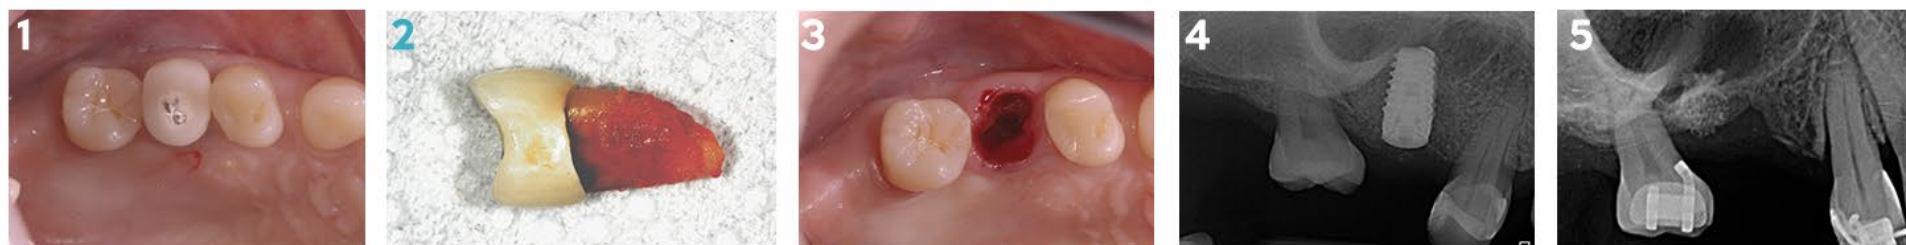
51 years old female patient lost tooth number 15 for endodontic and periodontal reasons (Fig 1, 2, and 3). Two months after extraction and implant placement, sinus lift was performed (Fig 4). The implant treatment failed after 4 months. The site was cleaned, the patient waited for two months to repeat the treatment (Fig 5). Orthodontic treatment was executed to distribute the spaces and to improve the occlusion.
