CLINICAL CASE: IMPLANT-SUPPORTED PROSTHESIS WITH DOUBLE BAR

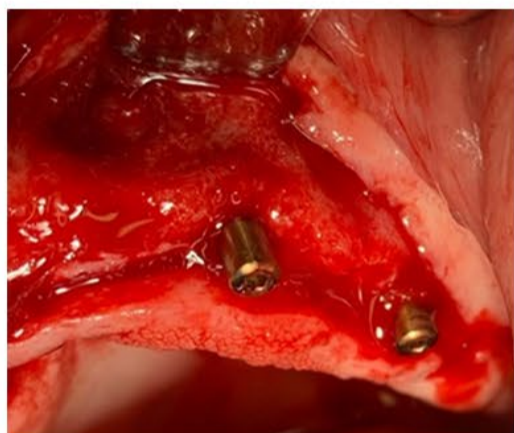
Situation after implant placement (Blue diamond 3.3mm diameter NC 10mm length)

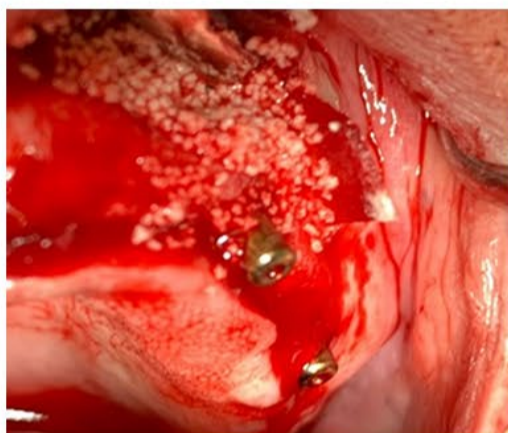
GBR using Novabone Morsels

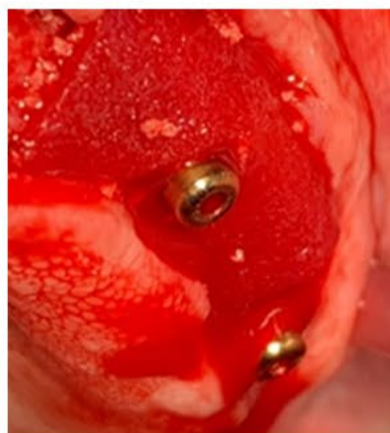
Placement of Osseoguard membrane Biomet 3i

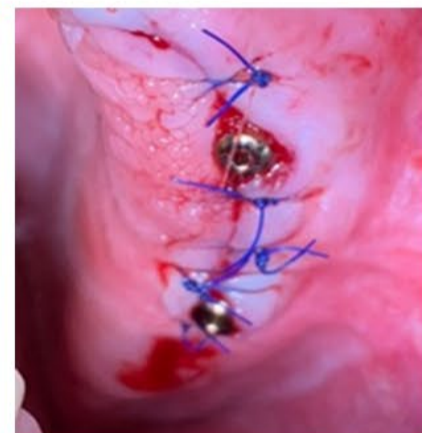
Clinical situation after suturing

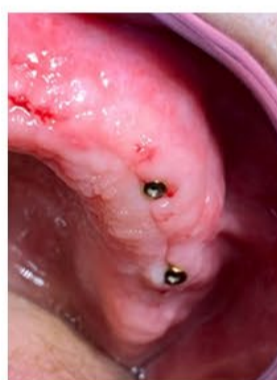
Situation after two weeks, sutures removed

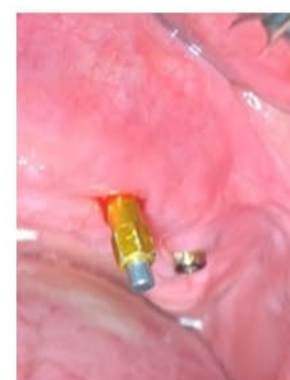
Situation after three months, ISQ measurement 73

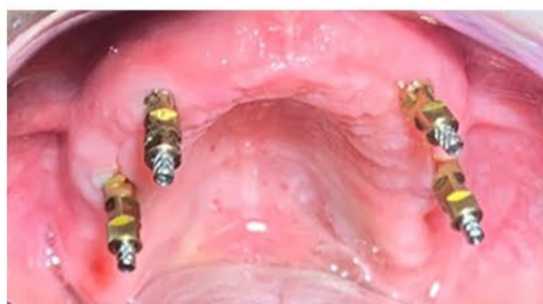
Impression posts in place

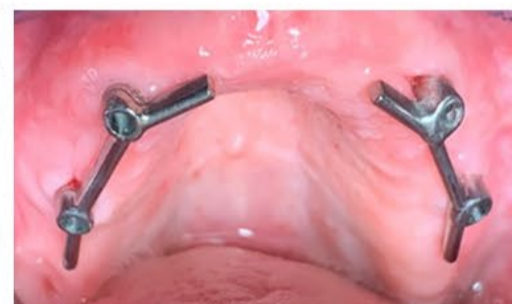
Bars placed
